DEFORMATION PROCESSES IN FORGING CERAMICS

Progress Report No. 2

8 July 1971 - 8 October 1971

Contract NASW-2187

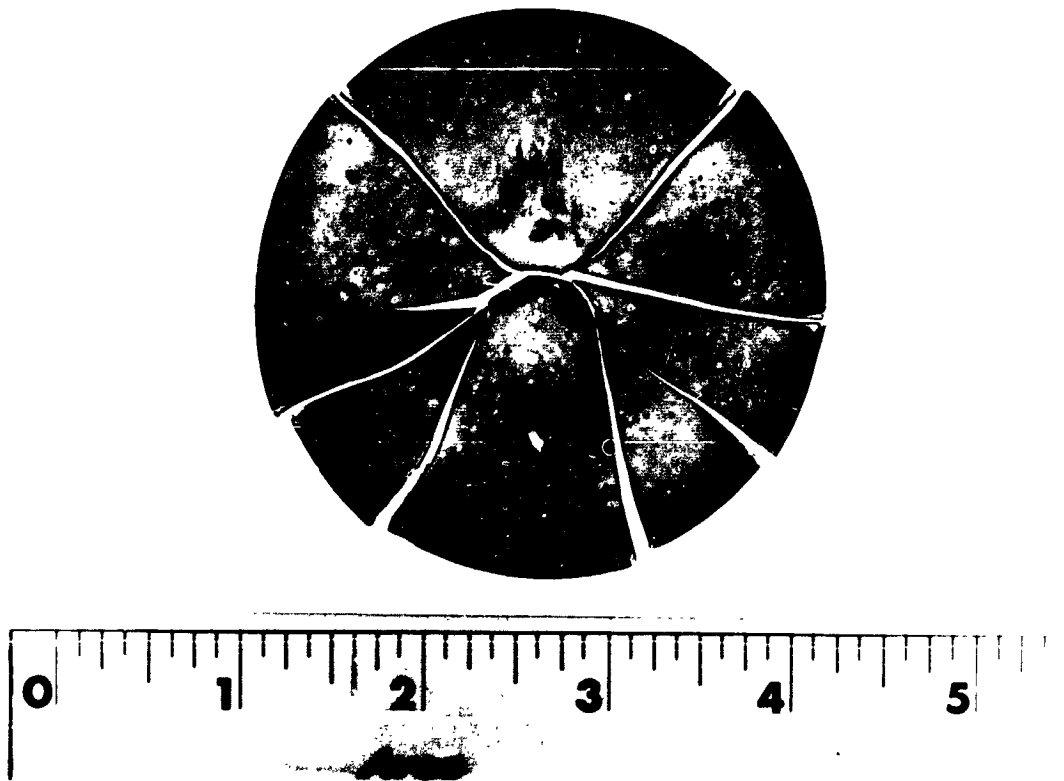
5603-1

The failure started at the center and propagated outward with several branches as seen in Figure 1. Examination of the fracture surfaces confirmed that the crack started in the center of the disc. However, it was surprising that the origin, as shown in Figure 2, appears to be at the surface on the punch side, which would be in compression from bending. In fact the plane of the crack was parallel to the scratches on the punch side left from surface grinding the blank. Crack initiation on the compressive side is not presently understood; even if stretching stresses were appreciable, the higher tensile stresses would still exist on the opposite side of the plate. This all suggests that contact stresses under the punch were important. One possible explanation is that the low deflection rate may have resulted from punch hang-up and that when the punch loosened, the immediate increase

Figure 1. Premature Cracking in Hemisphere Run D1762. Most of the observable bending occurred after fracture.

in load was sufficient to initiate fracture. An alternative possibility is that grain growth was greater than expected for the long forging time and the possible strain rate was then significantly reduced. These possibilities will not be resolved until microstructural examination of the piece is complete.

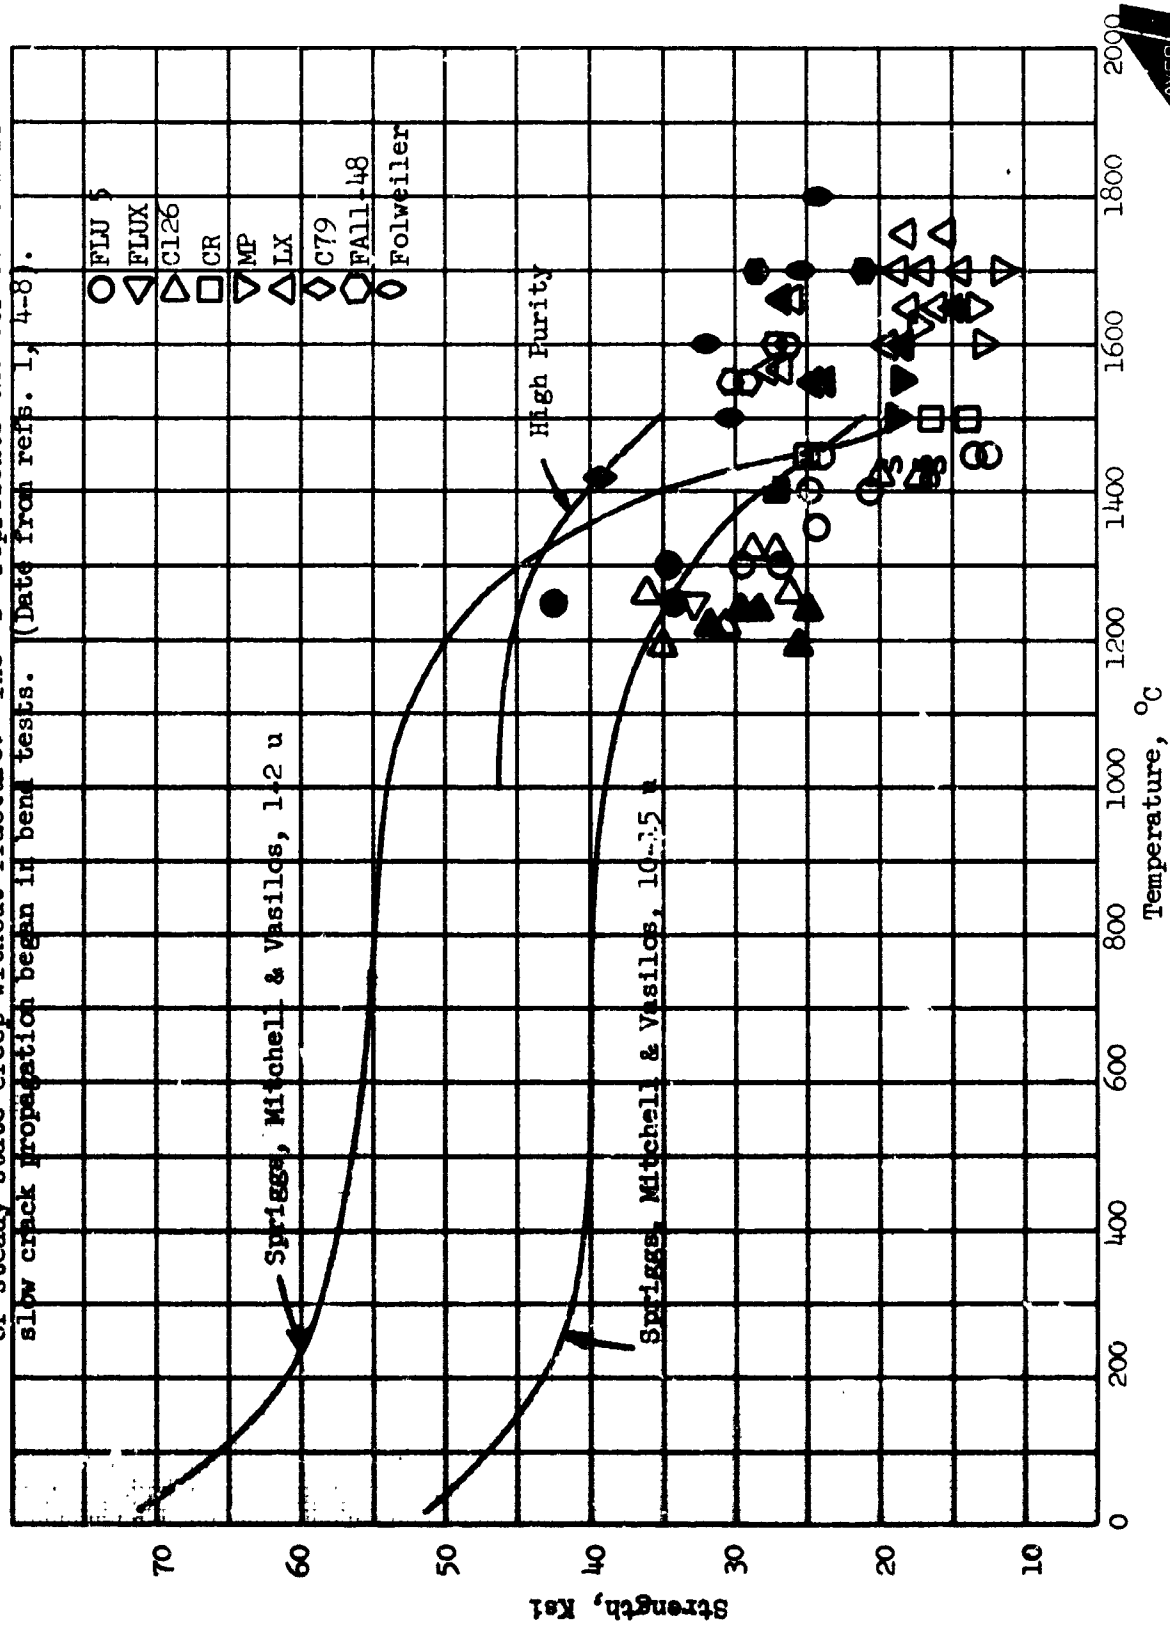
As can be seen in Figure 3, these data indicate a rather broad range of fracture stresses. This is not surprising considering the range of grain sizes and strains before failure which are included. At high temperature, the fracture behavior can be broken into two broad categories. At sufficiently high stresses, the fracture is rapid and the fracture surfaces are brittle in appearance. This behavior can qualitatively be considered in terms of a Griffith fracture criterion, in the sense that rapid fracture occurs when the flaw size becomes critical. Where plastic flow is occurring, the critical flaws may develop as a result of growth of intrinsic flaws or grain boundary separation before the rapid crack propagation stage; it is anticipated that this may result in a reduction in fracture stress compared to that of the unstrained material tested at higher rates.

Figure 3. Compilation of Fracture Stress at Temperature for Polycrystalline  $Al_2O_3$ . The full symbols represent actual fracture and the open symbols represent achievement of steady state-creep without fracture. The 's' represents the stress at which slow crack propagation began in bend tests. (Data from refs. 1, 4-8).

Comparing the nominal stress value of 12 Ksi, which was calculated for the hemisphere forging, D1762, previously discussed, it can be seen that this value is somewhat low, but not totally unreasonable. It should be noted, however, that the fracture occurred at a very low strain; the maximum bending strain was calculated to be about 0.2% when failure occurred. This value is then somewhat low for brittle fracture to occur even considering that the stress is biaxial.

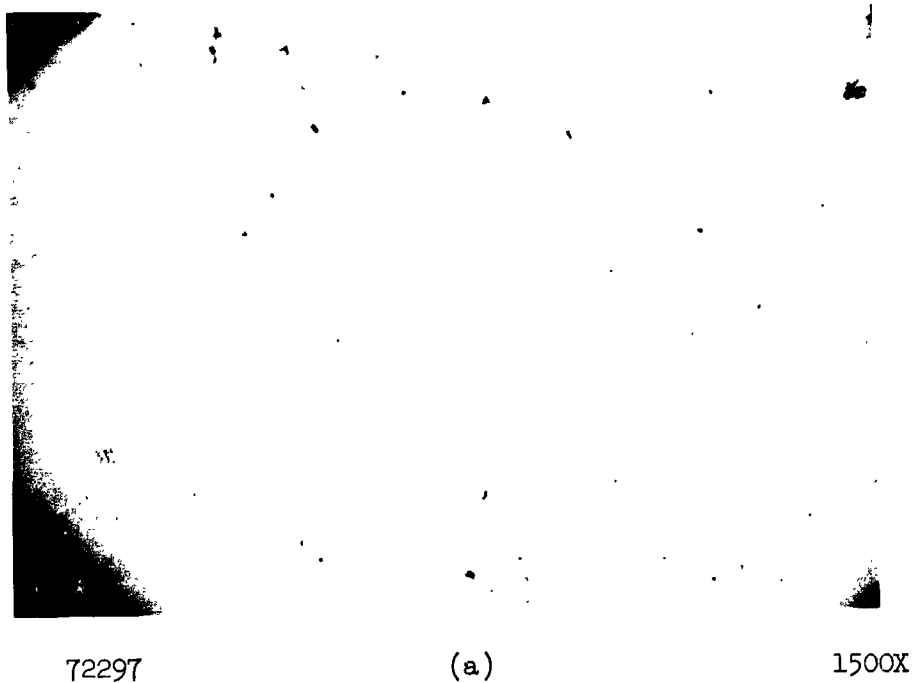
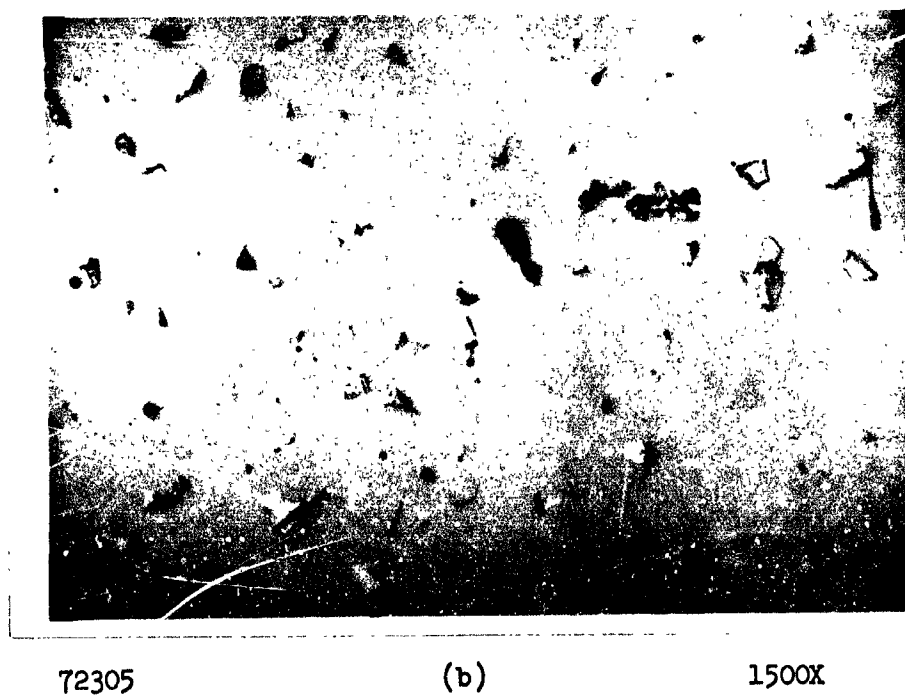
Micrographs are shown in Figures 4, 5, and 6 of typical regions in the cross-section near the O.D., from the center, and near the I.D., providing a scan along the strain gradient. These show an increase in the amount of grain boundary cavitation with the increase in strain. The difficulty in assessing the actual amount of cavitation can be appreciated by comparing the as-polished and the etched views. It is obvious that etching significantly increases the apparent amount of porosity. It is not certain, however, whether this occurs because the triple points have porosity which is not apparent in the as-polished condition, or simply because of other effects such as higher residual strains at the points of constraint to grain boundary sliding. Most of the cavitation is at triple points rather than along grain faces. Areas from D1600 in the regions of high strain were similar in nature to these micrographs.

Figure 4. Cross-Section of Hemisphere D1442 Near the O.D. in the (a) Polished, and (b) Polished and Etched Condition.
